# Impact of Land Use and Erosion on Radoviska Reka and Sushica Flooding in 2008

Ivan Blinkov<sup>1</sup>, Daniela Irotova Lazareva<sup>1</sup>

<sup>1</sup>Ss Cyril and Methodius University in Skopje, Faculty of Forestry, Dept. of Land and Water, Skopje, bul. Aleksandar Makedonski bb, MK-1000 Skopje, Republic of Macedonia

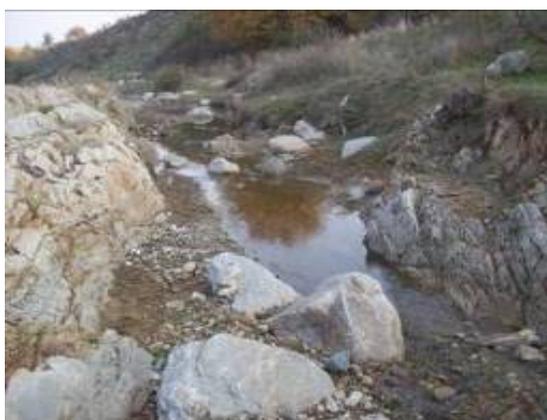
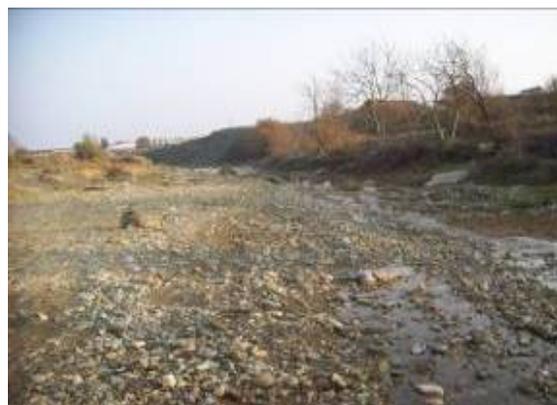
a) gorge part (bed load)

b) sedimentation near entering to the city

**Figure 14.** Sushica basin and stream bed

Because land cover on Sushica basin is very high favorable for erosion processes, almost everywhere is presented pluvial erosion processes. Steep slope in the upper part of the basin enable transport of the sediment downstream. In the mid part of the basin stream bed is narrow, water depth in a case of storm event is higher, hydraulic radius is higher and stream velocity is higher. It enables fluvial erosion processes in the stream bed. Depend on the water flow, velocity and energy, sediment including debris is a subject of transport downstream. During storm event, stream velocity in the mid part where stream bed slope is 3-4%, according to Hjulstrom's Diagram, when stream velocity is higher of 2 m/s, fluvial erosion is enabled and all particles lower than 100 mm are transported downstream. Near the entering to the city streambed expands but slope decrease up to 1,12%, Then depend on the water discharge, stream velocity, hydraulic radius, become aggradations of the sediment in the bed. Although this stream was recognized as dangerous in past, and final design was prepared in 1973, it was only partially implemented. Few cross structures for stabilizing stream bed were built in the urban area near the bridges. Unfortunately a designed check dam hasn't been built and planned biotechnical works hasn't been implemented too. It is a reason for further high erosion processes, smooth transport and deposition of the sediment on the entering to the city.

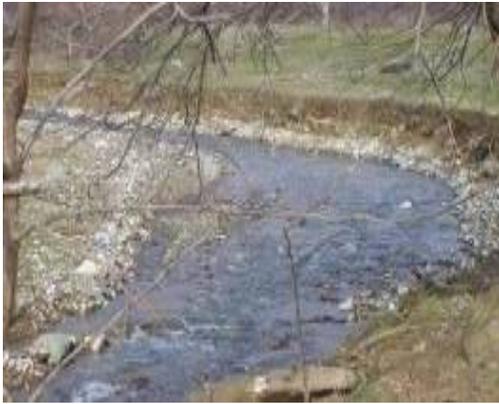
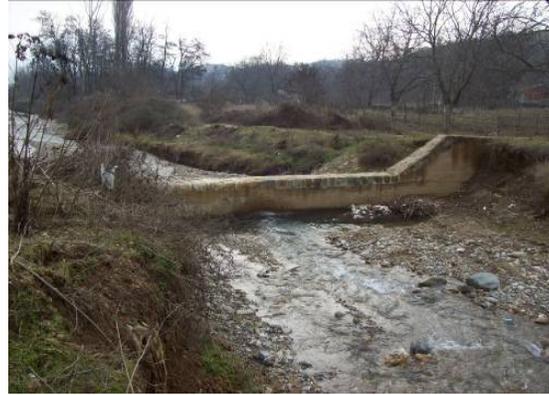
a) fluvial erosion in the streambed

b) check dam for retention sediments

**Figure 15.** Radoviska Reka stream bed

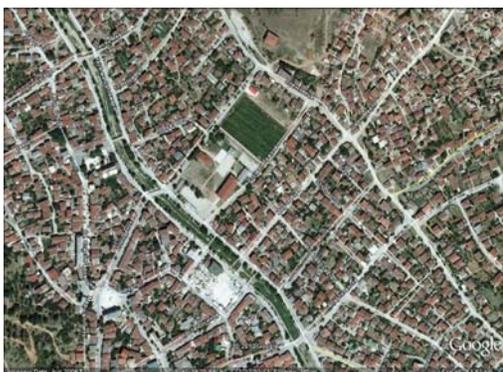
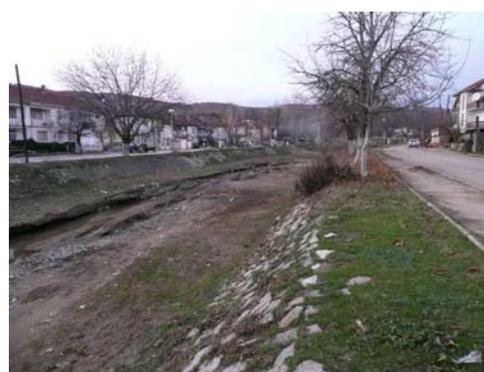
**Figure 16.** Central part of Radoviska and Radoviska Reka and streets along it

Detail urban plan of the central part of city of Radovis, where Radoviska Reka pass, is appropriate relate to minimizing flood damages

Along the river there are two streets that enable “open corridor” for flood wave and minimizing damages. According to the final design from 1973, Radoviska Reka was trained with open trapeze shaped channel with dimension  $a = 20 \text{ m}$ ,  $h = 2,05$  According to the design, this channel is dimensioned on a 1% peak flow probability,  $Q_{1\%}=152 \text{ m}^3/\text{s}$ .

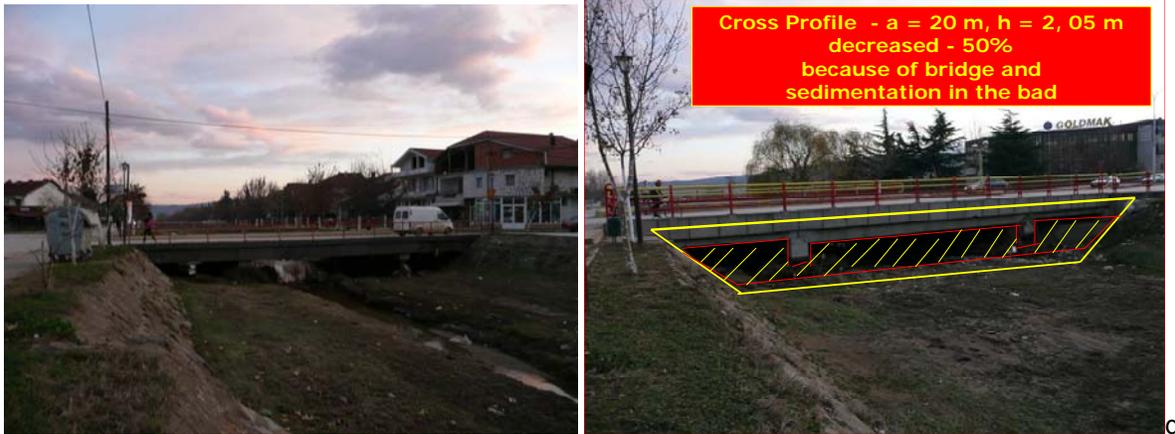
The main problem in Radoviska Reka is bridges. 9 bridges pass Radoviska Reka, out of them 7 are irregularly set into the river bed.

**Figure 17.** Irregular bridges close the Radoviska Reka stream bed – Karadacki Bridge

According to the measuring and calculation, during the flood event 2008, flow capacity of the streambed near Karadacki Bridge (the first of irregular bridges) was approximately  $56 \text{ m}^3/\text{s}$ . After the flood the bed was cleaned from sediments, then “open area” under the same bridge was measured again, and the calculated flow capacity was  $Q = 84 \text{ m}^3/\text{s}$ . (instead of designed 152). It is approximately equal to 10% flow probability. It is so far from standards in Macedonia. Situation with the second bridge (Ancient Roman bridge reconstructed in the 80's) is worse. Open area of original bridge was something less than  $30 \text{ m}^2$  that and it enabled about  $110 \text{ m}^3/\text{s}$ . This bridge was critical in past too, but because of significance as cultural heritage no activities were carried out related to it. After it collapses in 1982, this bridge was reconstructed. Wishing to build stronger construction, designer enlarges dimensions of the bridge, but it decreases open area and flow capacity. Before the flood 2008, flow capacity of this bridge was calculated as  $Q = 41 \text{ m}^3/\text{s}$ . After cleaning of the bed, flow capacity increase on about  $Q = 70 \text{ m}^3/\text{s}$  that is equal to approximately to 16% peak flow probability.

It means that this action would slightly mitigate the flood hazard, but the main problem with irregularly built bridges is not solved.

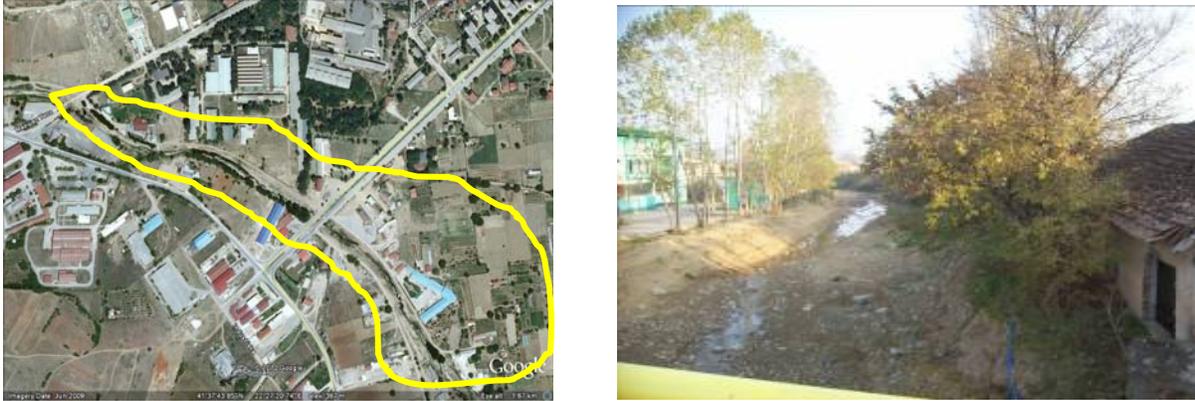
Torrent Sushica pass in the new, industrial part of the city of Radovis. Detail urban plan for this area is prepared but not implemented. Situation and location of the constructions is favorable for increase of damages. Some constructions are much closed to the streambed (figure 20).

**Figure 19.** A view on Sushica vicinity and devastated area during flood 2008

A problem that contributed to the damages was illegal landfill of constructive solid waste located not so far from the city. Beside other erosive material, large part of material on the landfill was eroded and transported to the city causing closing of the bridges. The first and oldest bridge was constructed regularly and debris flow easily pass under this bridge. The second bridge (the old entrance to the city) was not properly constructed (figure 21). Huge amount of sediment and debris closed the bridge profile and the bridge collapsed (figure 22). Flood wave took each mobile thing including parked truck near the stream. This large amount of sediment and debris closed the third bridge (the newest one). Although according to the witnesses, water “moved” the bridge it “survived”. Then the debris flow jumps the bridge and flooded all vicinity of the stream and covered with sediments.

Cost of damages by Sushica only on private property was about 2,3 million Euros. It means that investments in erosion control works in Sushica basin are lower compared with damages from flood 2008. Because these investments could solve the problem, it is fully recommended to be carried out.

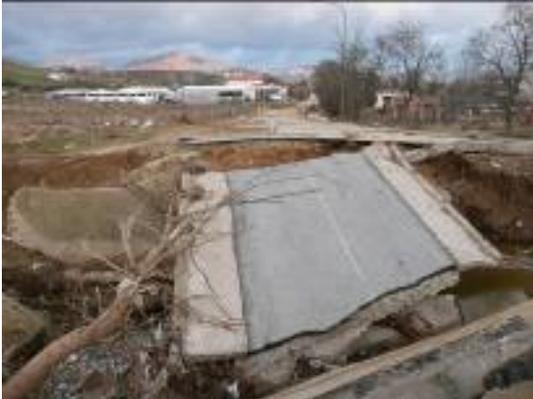
**Figure 20a.** The second bridge (collapsed 2008),

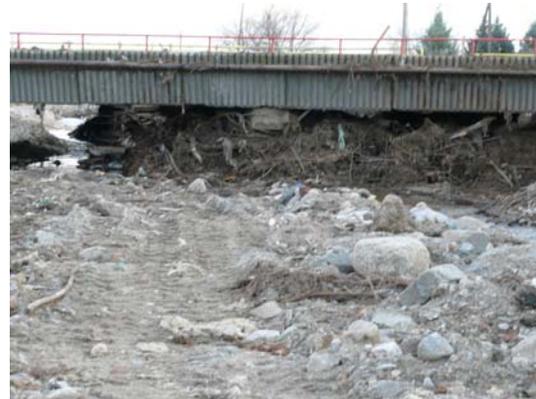
**Figure 20b.** The third bridge (closed, 2008)
